Accessibility Study : Portage la Prairie City Hall

City of Portage la Prairie
January 24, 2020

REPUBLIC
ARCHITECTURE
INC

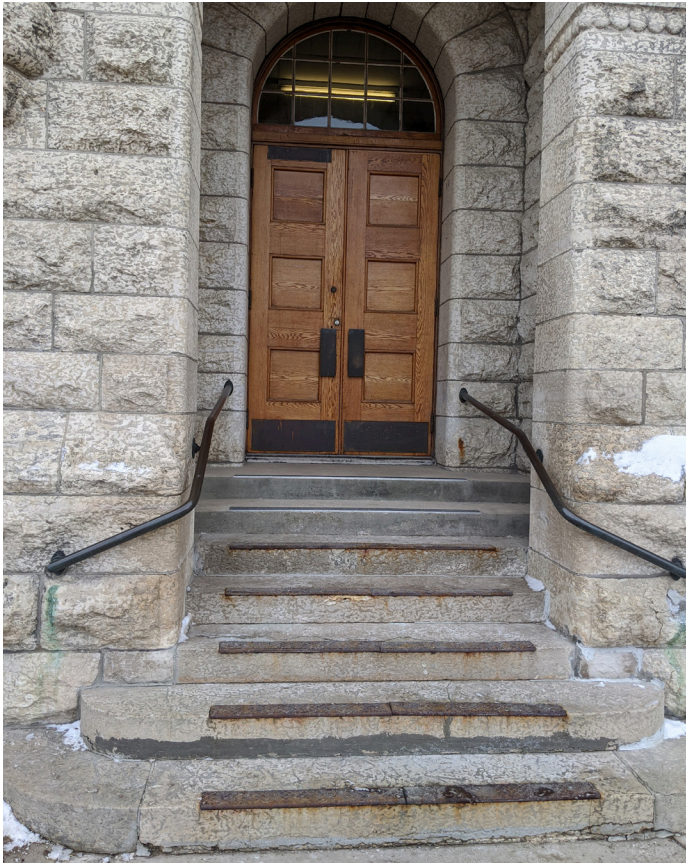
The top landing is too shallow to provide proper clearance in front of the doors. The handrails do not extend 300 mm beyond the top and bottom stair treads. There is no detectable warning surface at the top of the stair.

The doors do not provide sufficient clear width. There is no power door operator on the doors.

Fig. 1 Northwest Entrance showing depth of landing, stairs and rails (Northeast similar)

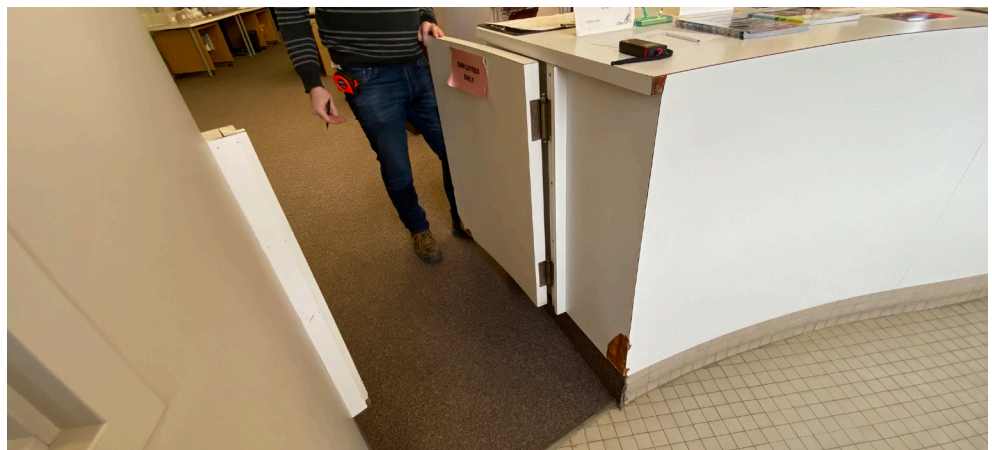
The gate leading through the service counter does not provide sufficient clear width, and the hardware installed to open and latch the gate is not considered code compliant.

Fig. 2 Service counter gate

- replace service counter gate
- provide accessible service counter
- 5. Second floor accessible routes and service
 - reconfigure council room doors

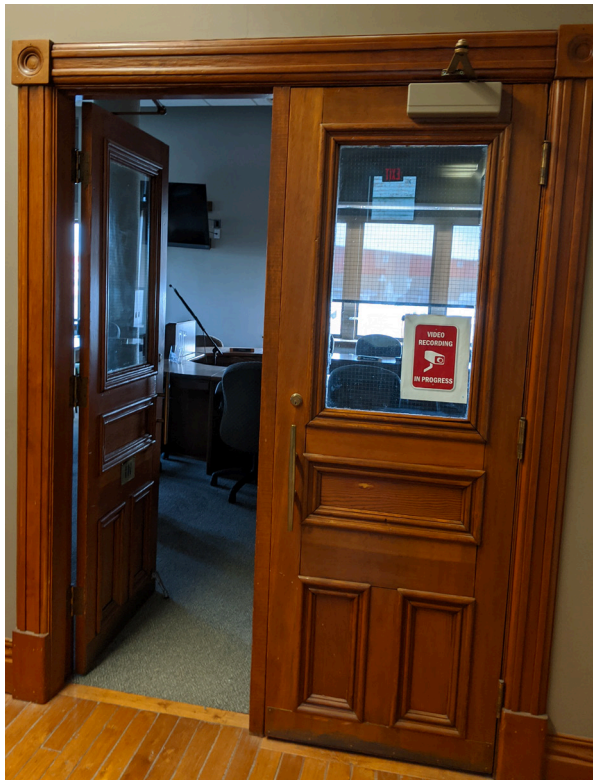
The main access doors in and out do not provide sufficient clear width, and the door swinging into the room creates an obstructed pathway with a nearby column.

Fig. 3 Double doors to Council Chamber with opposing doorswings and centre post

Also to be considered is how individuals with accessibility needs move throughout all areas of the building. On main floor, replacement of the existing door at Corridor 117 is recommended, as well as providing new access through the service counter. Addressing the lack of a suitable service counter for individuals in a wheelchair is necessary, to be achieved by modifications to the existing large service counter and potentially reworking the layout of serving staff. Some modifications to interior layouts, especially to accommodate the new public access point and lift will be necessary. On the second floor, modifications to the swing and removal of the centre post of the Council Chamber doors is required.

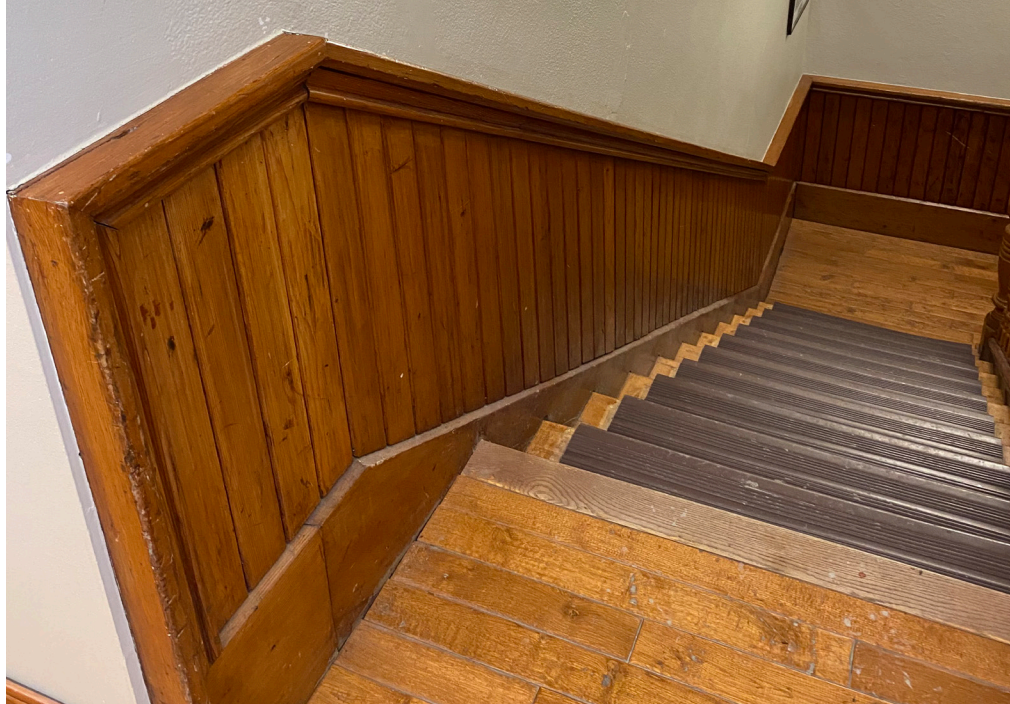
The main stair (between main and second floor) does not have a continuous handrail on either side, and there is no detectable warning surface at the top of the stair.

Fig. 4 Stair at second floor; suggested perimeter rail location above wainscoting

The existing stair from main to second floor requires the addition of a new continuous handrail around the perimeter of the stair. The small stair providing emergency egress from the Council Chamber is also recommended to be improved by adding compliant handrails and modifying the stair to have compliant rise and run.

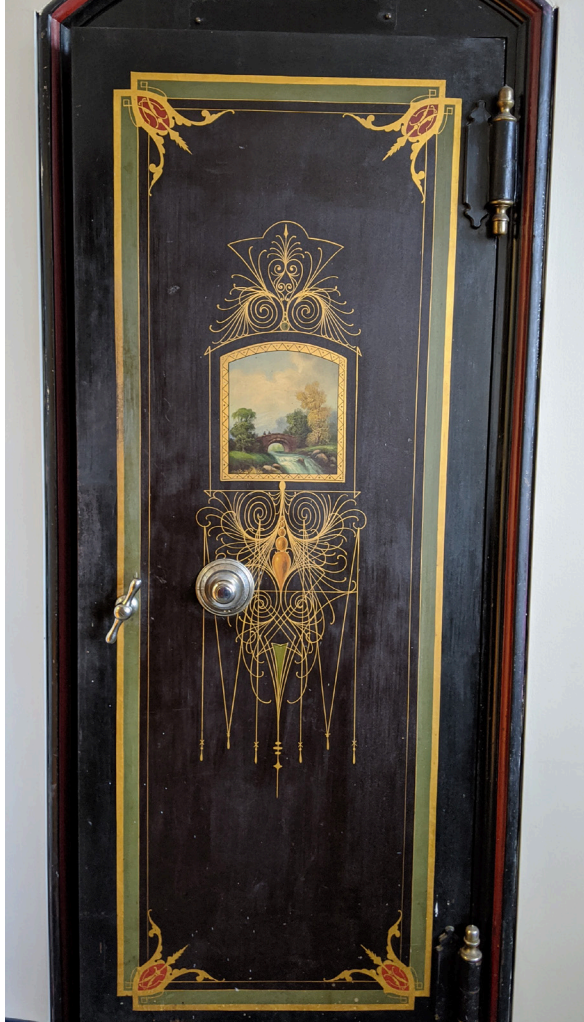
Fig. 7 Original Vault door recommended for conservation

The next most significant item is providing access from main floor to second floor. To provide a passenger lift, we recommend demolishing the existing concrete structure at the main and second floor vaults. By design, this structure is independent from the surrounding building structure and could be removed, leaving a suitable location and underlying foundation for a new lift. As noted, we recommend conserving elements of the vaults such as the doors to be featured in the new lift as an homage to this previous building function.

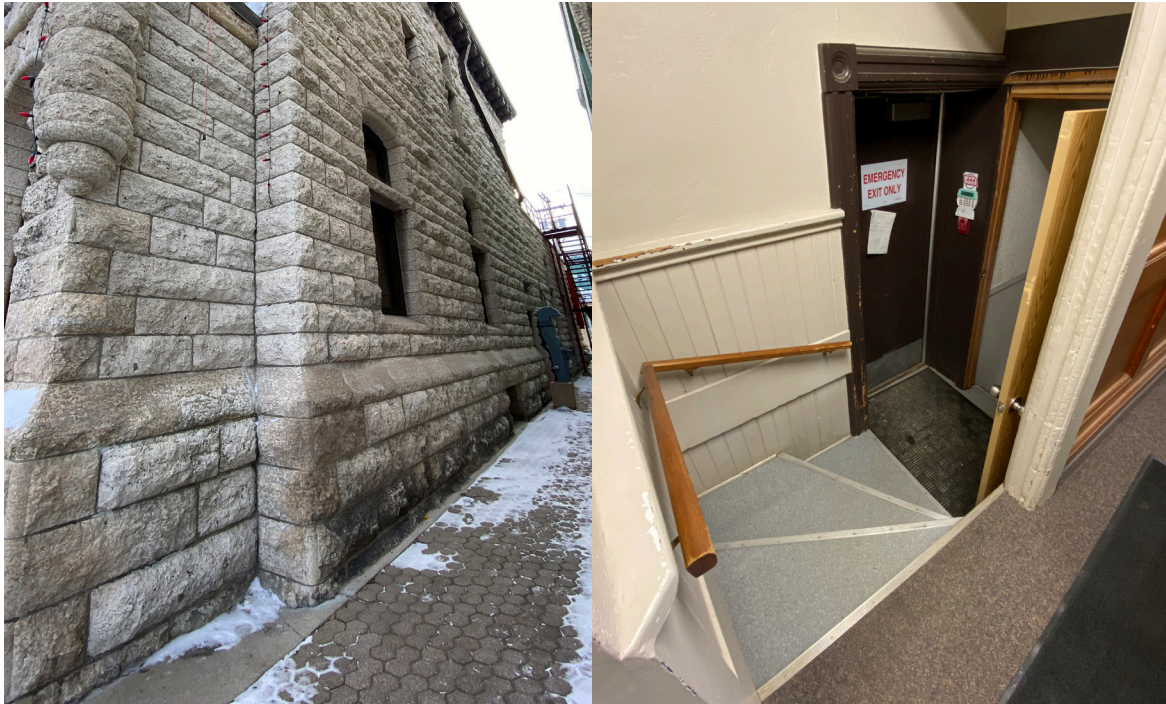
Fig. 9 Side Entrance; recommend providing ramp access up to main floor level

To achieve ramp access to the side entrance, the existing door opening would need to be widened to accommodate an accessible door. Within the building, the existing stair to the basement would be removed as winder stairs are not compliant, and a platform for entrance at main floor level is required. Access throughout the basement would be by the existing stair

and a new opening through the foundation wall dividing the basement. The new ramp would extend from the side entrance out to the front sidewalk and would provide a dignified entrance for the public to use when conducting regular business with City of Portage la Prairie.

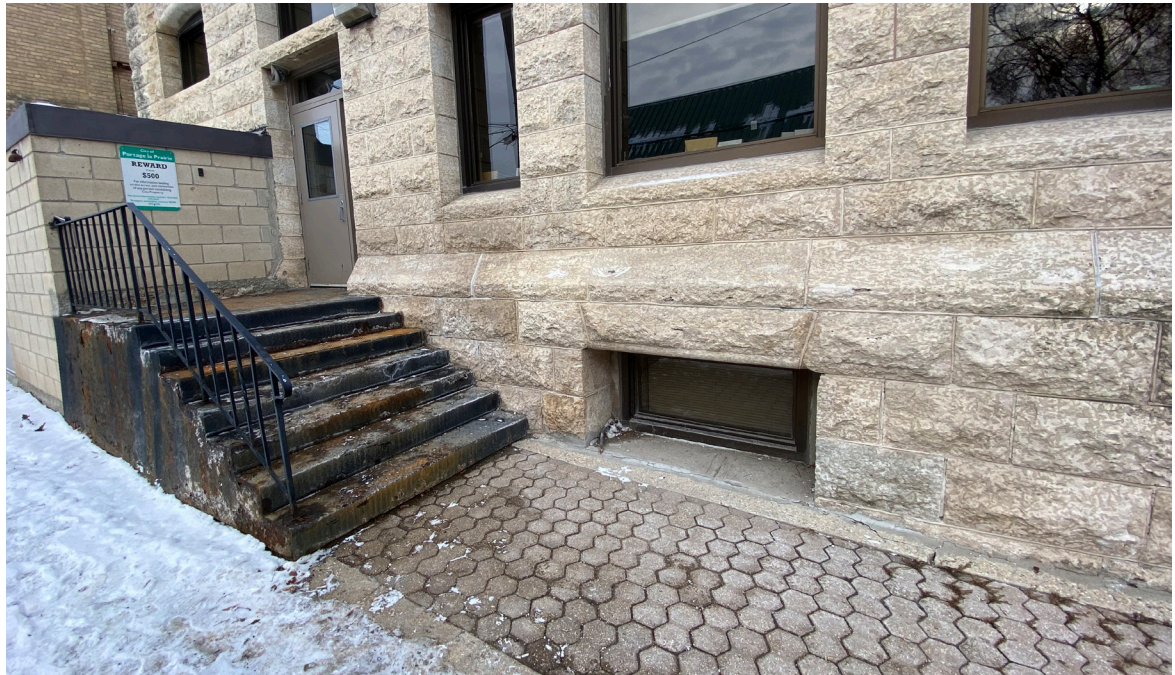
There are not handrails on both sides of the stair. The handrail does not extend 300 mm beyond the bottom stair tread. There is no detectable warning surface at the top of the stair.

There is no power door operator on the doors.

Fig. 8 Rear Entrance; recommend replacement with entrance ramp

At the rear of the building, universal access could be achieved by demolishing the existing stairs and landing, which are in poor condition, and providing a new landing with a ramp extending

to the east, then switching back. This rear ramp would be conveniently located near parking for staff and public use.
