Accessibility Study : Portage la Prairie City Hall

City of Portage la Prairie
January 24, 2020

REPUBLIC
ARCHITECTURE
INC

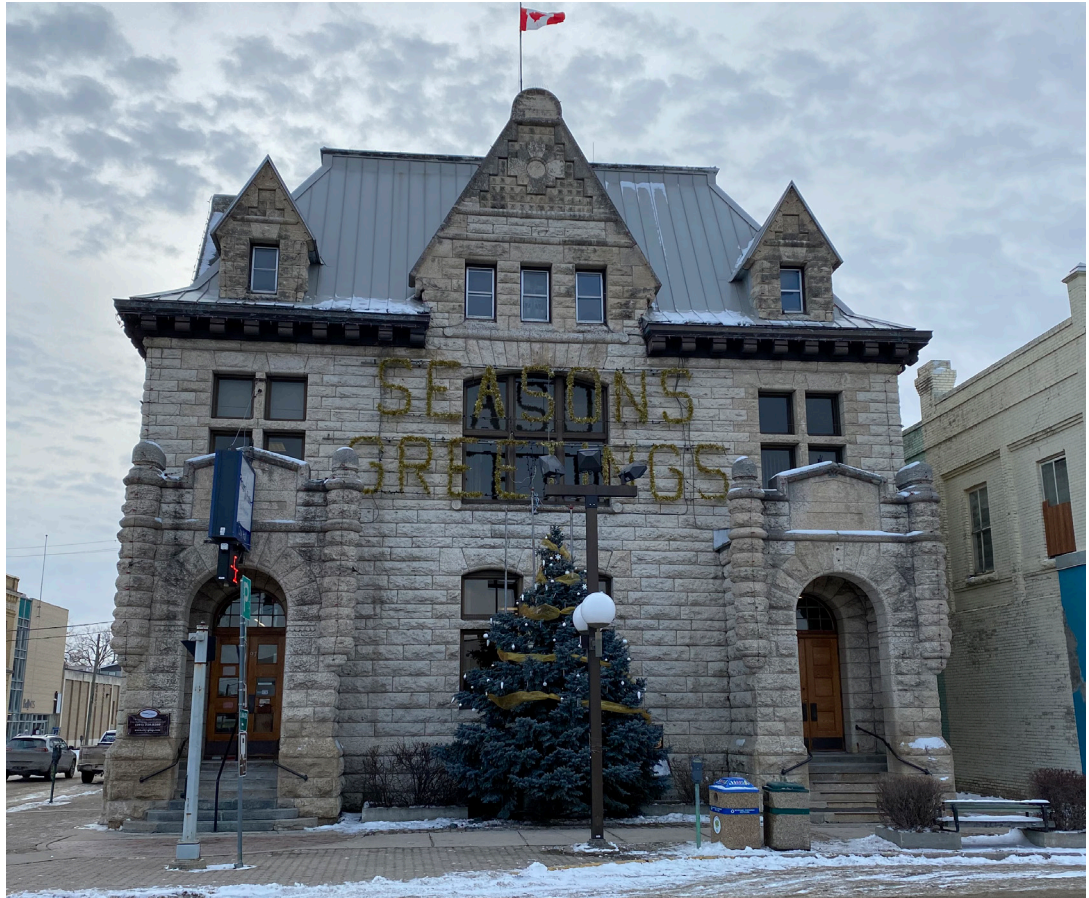
Fig. 5 Front Elevation showing prominent Character-Defining Elements
